SBS HOME INSPECTION RESIDENTIAL INSPECTION REPORT

1234 Main st.
Saint Cloud, FL 34772

Buyer Name
08/15/2022 9:00AM

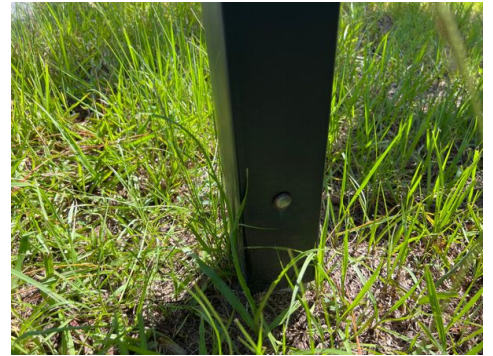
SLIGHTLY LOOSE

Mailbox only being held by one bolt. A second or Third bolt attachment recommended.

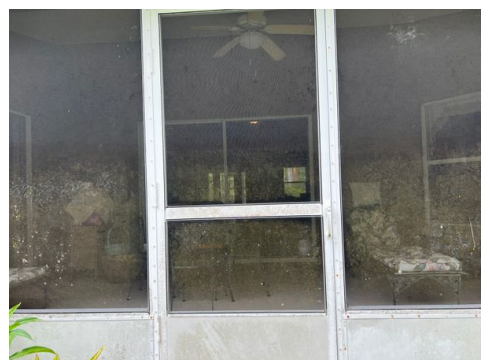
At the time of the inspection there was a large amount of mildew on the back porch door and screens. Cleaning by a qualified professional recommended.

Contact a qualified professional.

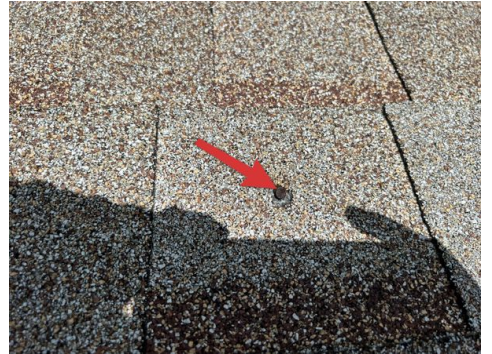
5.2.1 Shingles / Shakes

Nail heads were exposed at one or more shingles. More than just a few exposed nail heads may indicate a substandard roof installation. Recommend applying an approved sealant over exposed nail heads now and as necessary in the future to prevent leaks.

Contact a qualified professional.

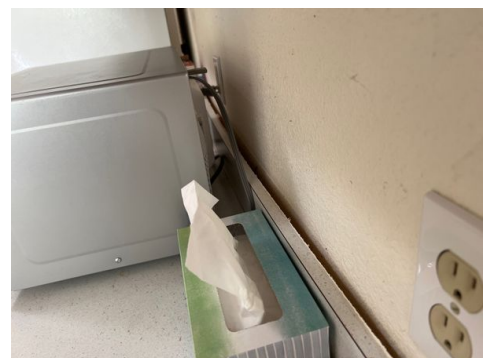
BACK BOARD SEPAEATION

At the time of the inspection the counter top backboard was separating/seperated from the wall. Reattachment recommended by a qualified professional.

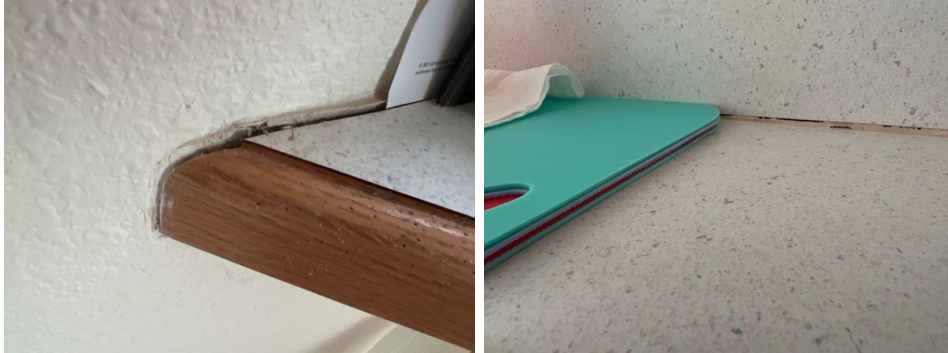
9.1.1 Counters

Gaps, no caulk, or substandard caulking were found *between countertops and backsplashes / around the sink*. Water may penetrate these areas and cause damage. Recommend that a qualified person repair as necessary. For example, by installing caulk.

Contact a qualified professional.

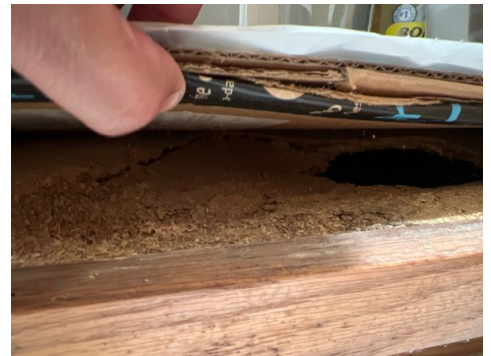
9.2.1 Cabinets

DAMAGED CABINET FLOORING

At the time of the inspection it was observed that there was a hole covered under a cardboard under the sink. Repairs/replacements recommended by a qualified professional.

Contact a qualified professional.

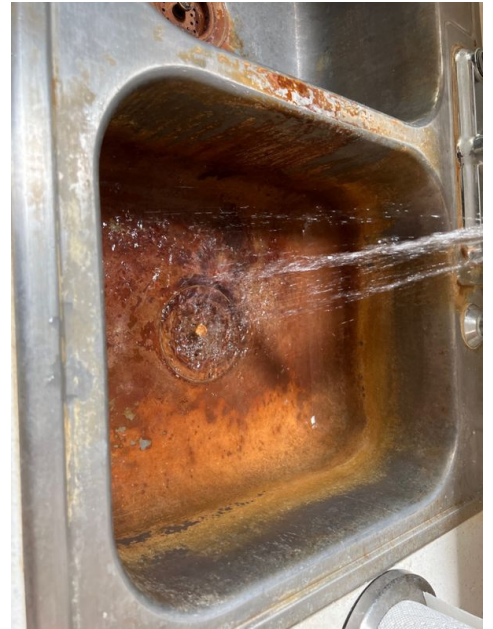
9.4.2 Sinks

SINK DAMAGED, REPLACE

The sink was damaged or significantly deteriorated due to excessive iron deposit build up. Recommend that a qualified contractor replace the sink.

Contact a qualified professional.

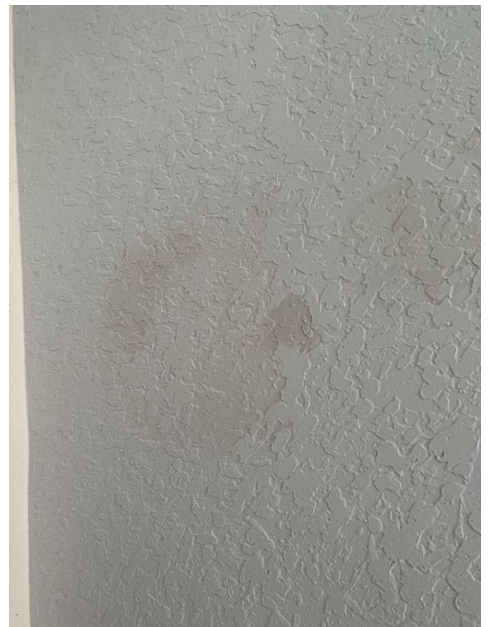
10.4.1 Walls, Ceilings and Fixtures

CEILING - DRY STAINS, MONITOR

Stains were found in one or more ceiling areas. However, no elevated levels of moisture were found. The stain(s) may be due to past roof and/or plumbing leaks. Consult with the property owner and monitor the stained area(s) in the future, especially after heavy or prolonged rain. If elevated moisture is found in the future, then recommend that a qualified contractor evaluate and repair as necessary.

Recommend monitoring.

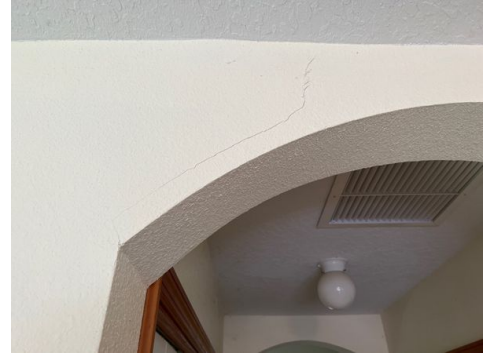
10.4.2 Walls, Ceilings and Fixtures

**NEEDS REPAIR**

One or more *walls / ceilings were damaged / were cracked / had substandard repairs*. Recommend that a qualified person repair as necessary.

Contact a qualified professional.

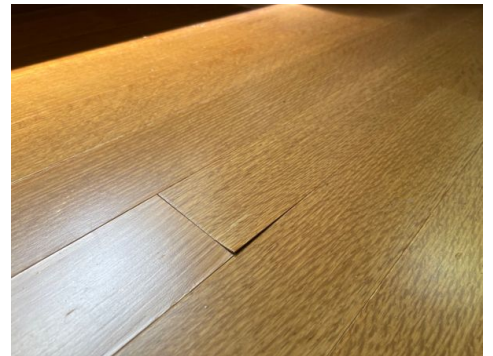
10.5.1 Floors

Vinyl, linoleum or marmoleum flooring in one or more areas was *damaged / deteriorated / loose / curling*. If in a wet area, water can damage the sub-floor as a result. Recommend that a qualified contractor replace or repair flooring as necessary.

Contact a qualified professional.

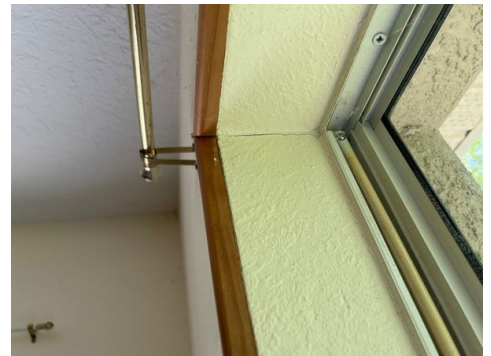
CRACKING

Cracking is common around the sliding glass doors and the windows where two materials come together. This is caused from the expanding and contracting of the similar materials. Recommend the area be caulked periodically.

Contact a handyman or DIY project

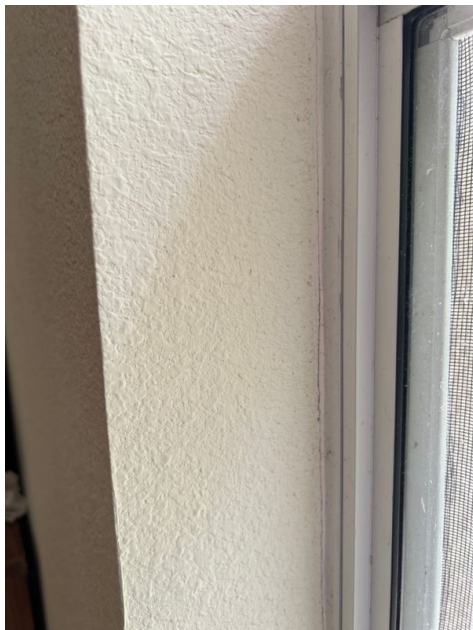
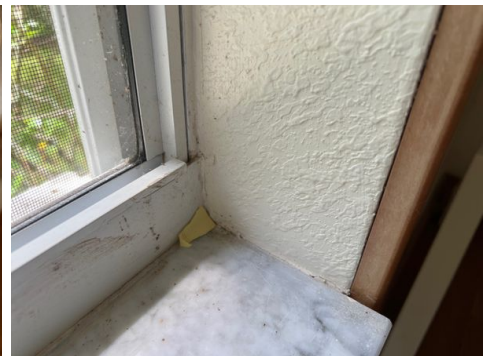
11.3.3 Windows & Skylights

At the time of the inspection it was discovered that portions of the system were in need of general maintenance and caulk application. Home owner application recommended.

Contact a qualified professional.

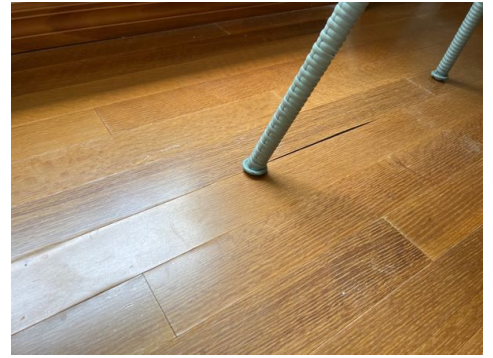
11.5.1 Floors

**VINYL, LINOLEUM, MARMOLEUM**

Vinyl, linoleum or marmoleum flooring in one or more areas was *damaged / deteriorated / loose / curling*. If in a wet area, water can damage the sub-floor as a result. Recommend that a qualified contractor replace or repair flooring as necessary.

Contact a qualified professional.

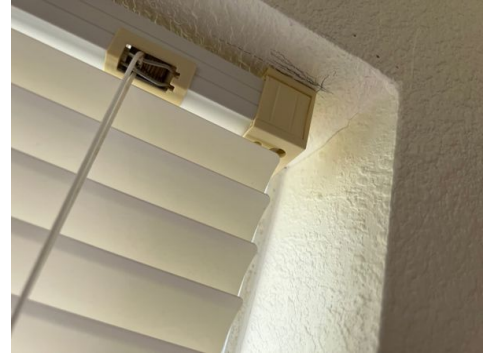
CRACKING

Cracking is common around the sliding glass doors and the windows where two materials come together. This is caused from the expanding and contracting of the similar materials. Recommend the area be caulked periodically.

Contact a handyman or DIY project

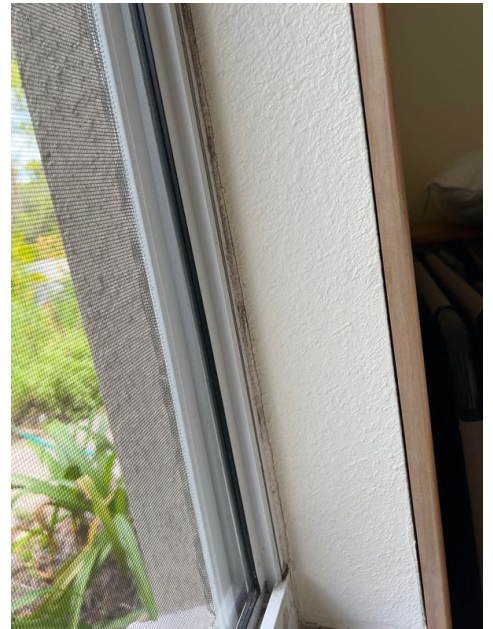
12.3.2 Windows & Skylights

At the time of the inspection it was discovered that portions of the system were in need of general maintenance and caulk application. Home owner application recommended.

Contact a qualified professional.

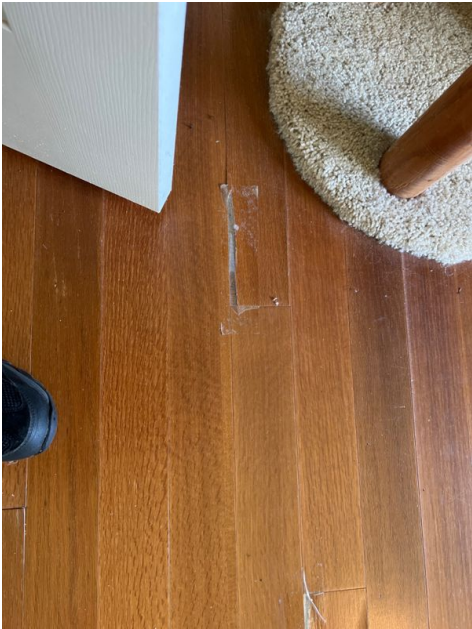
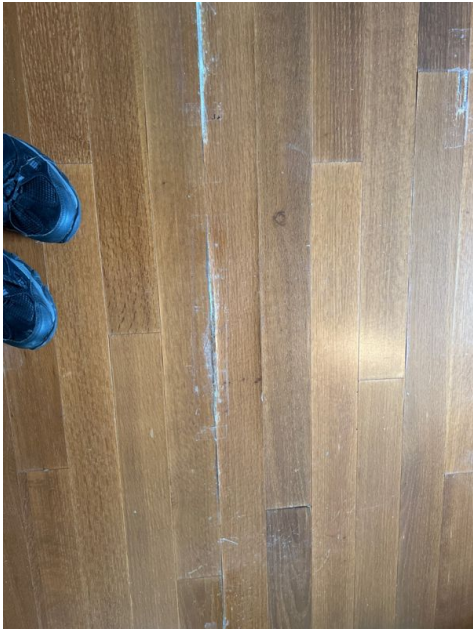
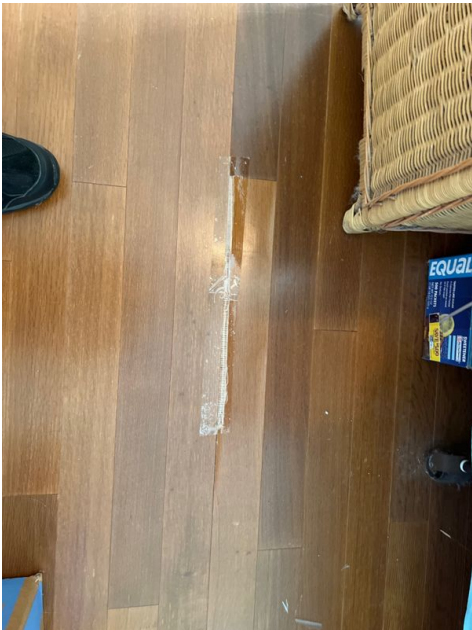
12.5.1 Floors

Vinyl, linoleum or marmoleum flooring in one or more areas was *damaged / deteriorated / loose / curling*. If in a wet area, water can damage the sub-floor as a result. Recommend that a qualified contractor replace or repair flooring as necessary.

Contact a qualified professional.

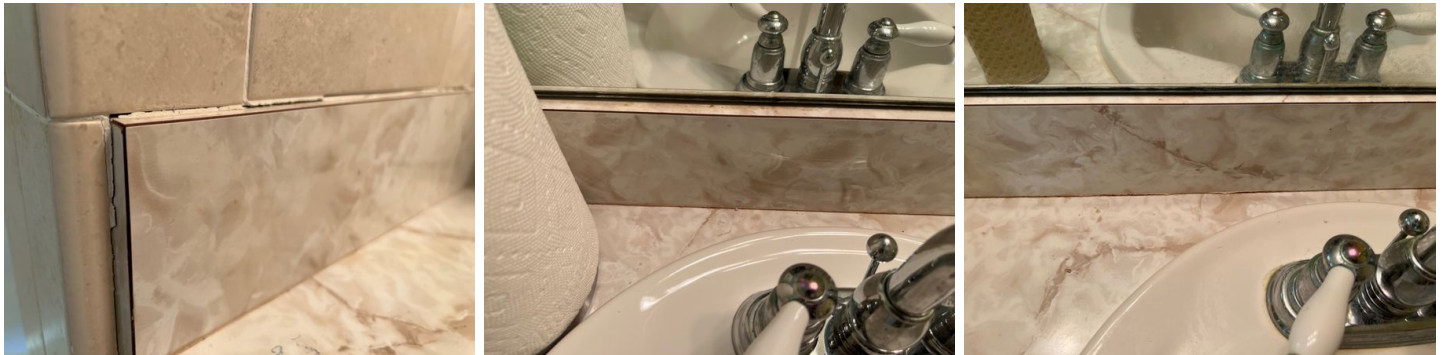
13.2.1 Counters

Gaps, no caulk, or substandard caulking were found *between countertops and backsplashes / around the sink*. Water can penetrate these areas and cause damage. Recommend that a qualified person repair as necessary. For example, by installing or replacing caulk.

Contact a qualified professional.

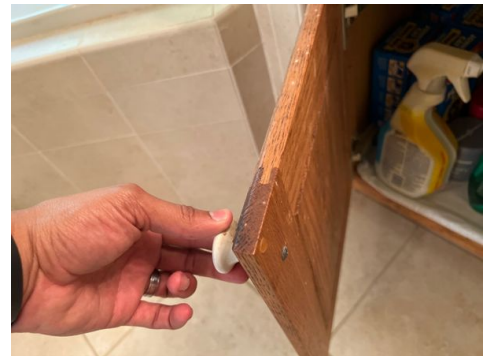
13.3.1 Cabinets

HARDWARE LOOSE, MISSING, DAMAGED

Cabinet hardware such as hinges, latches, closers, magnets or pulls were loose, missing or damaged at one or more cabinet drawers, doors or turntables. Recommend that a qualified person repair as necessary.

Contact a qualified professional.

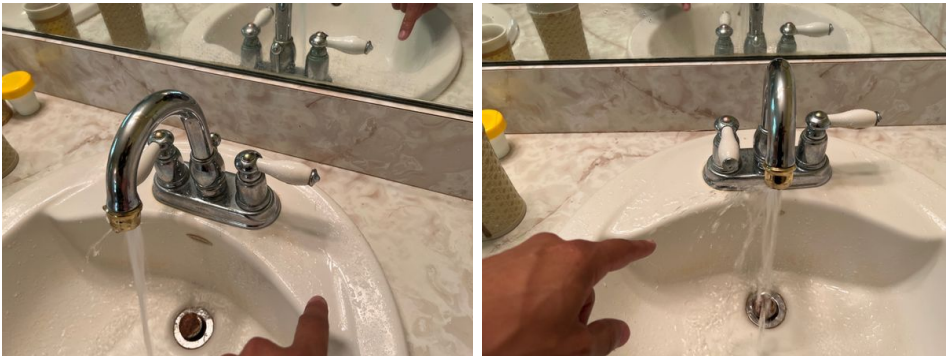
13.5.1 Sinks

LEAKING AT BASE, HANDLES

Water was leaking at the sink faucet base or handles. Recommend that a qualified plumber repair as necessary.

Contact a qualified professional.

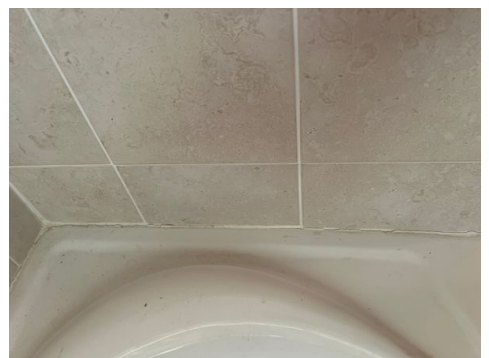
Gaps, no caulk, or substandard caulking were found between the bathtub and the *floor / walls*. Water may penetrate these areas and cause damage. Recommend that a qualified person re-caulk or install caulking as necessary.

Contact a qualified professional.

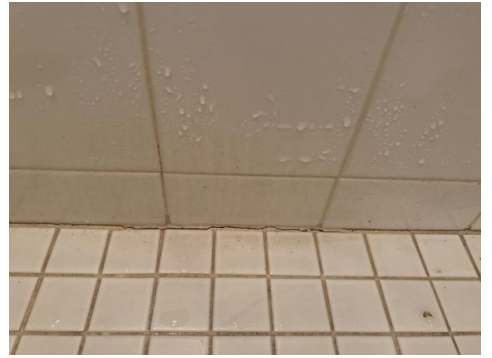
14.6.1 Showers

At the time of the inspection it was noticed that portions of the shower grout had deteriorated. New grout installation recommended.

Contact a qualified professional.

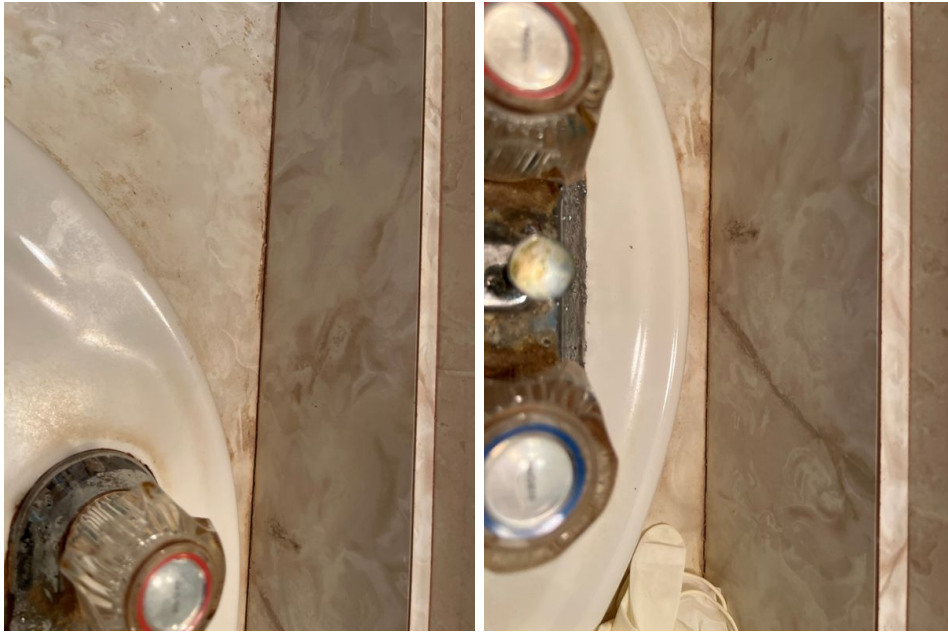
15.2.1 Counters

Gaps, no caulk, or substandard caulking were found *between countertops and backsplashes / around the sink*. Water can penetrate these areas and cause damage. Recommend that a qualified person repair as necessary. For example, by installing or replacing caulk.

Contact a qualified professional.

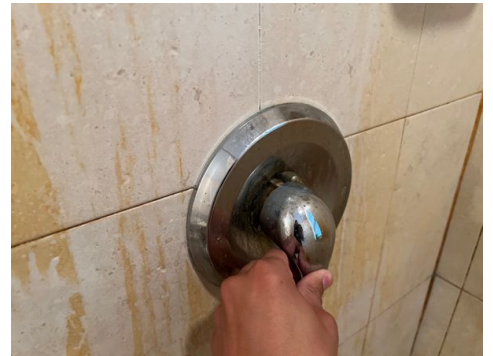
15.7.1 Showers

HANDLES

Handles controlling water flow to the shower were *missing / loose*. Recommend that a qualified person repair or replace handles as necessary.

Contact a qualified professional.

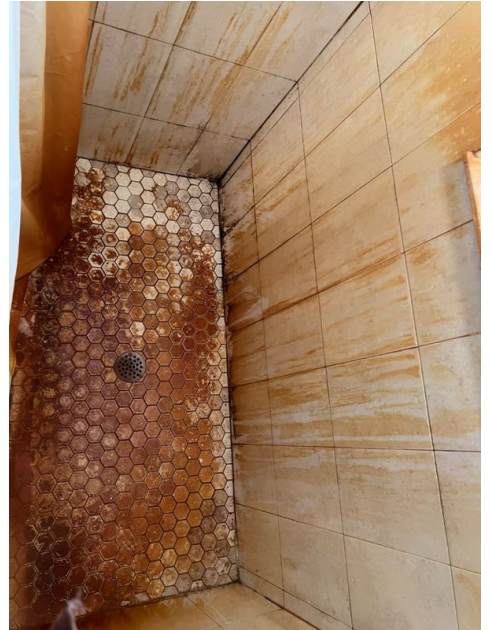
At the time of the inspection it was discovered that the shower had excessive iron deposit build up. Heavy cleaning recommended.

Contact a qualified professional.

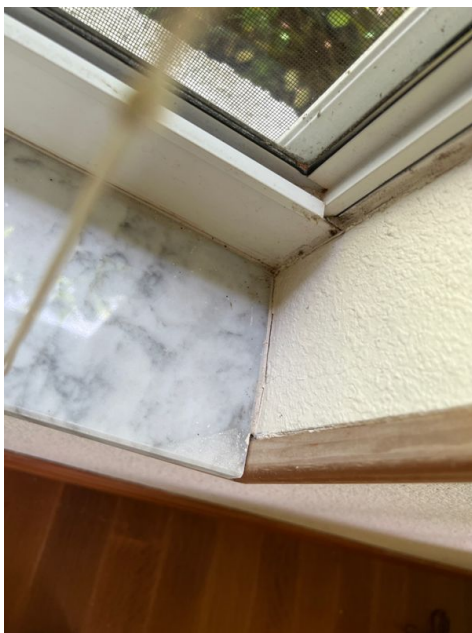
At the time of the inspection it was discovered that portions of the system were in need of general maintenance and caulk application. Home owner application recommended.

Contact a qualified professional.
